ITC
INDEPENDENT TURBINE CONSULTING, LLC

Turbine Outage Lessons Learned and GT Maintenance Case Studies

Scott Cavendish, PE

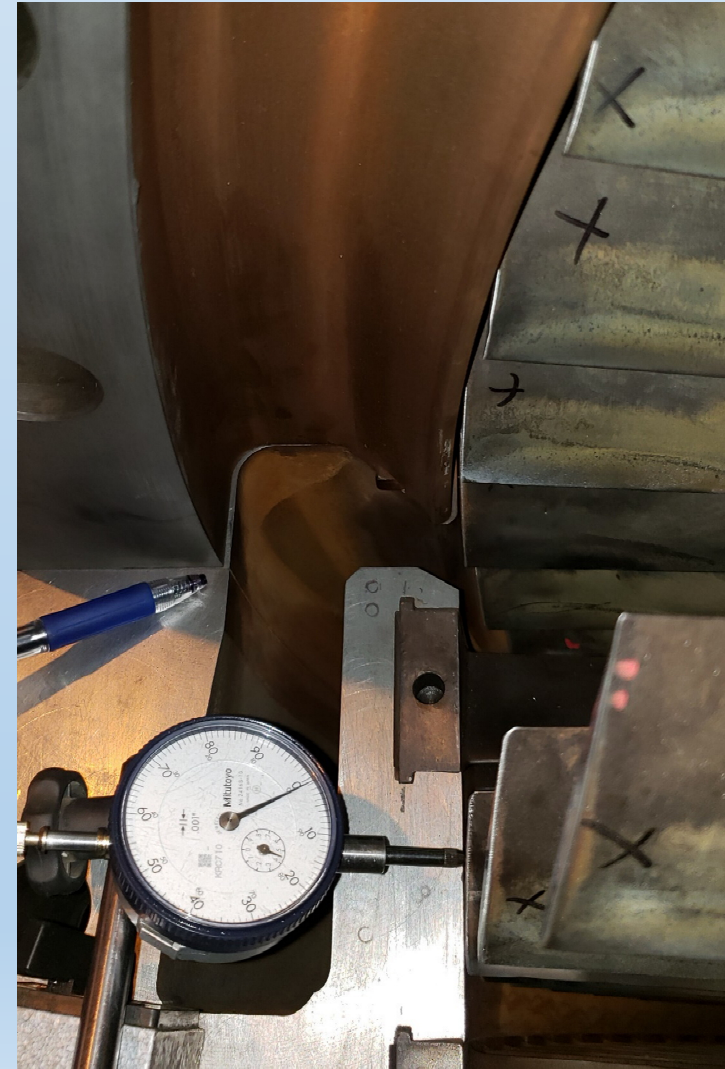
Compressor Casing Bore Steps

- A 7EA turbine owner reported great difficulty with operating the turbine since the last major inspection, and significant vibration events after the prior major.
- A consulting engineer was brought in to direct the next major inspection.
- Several compressor issues were identified, including:
 - Heavy rubs at the compressor horizontal joints on only one casing half,
 - Upon reassembly, half-shell clearances were very tight in this area,
 - Upon installing casing with dowels, a significant step was still present at the inner casing bore adjacent to blade tips.

- The Root Cause of the bore misalignment was yielded dowel holes, resulting in dowels that did not align casings as expected.
- The misaligned dowel holes were caused by heavy handed dowel installation that yielded casing dowel holes, and resulted in casing joint steps.
- To correct, upper and lower casing bores were aligned under pressure to eliminate steps, then doweled and bolted in place to align the bores.
 - A recommendation was made to align and re-establish new larger dowel holes at a subsequent outage.
- The result – The unit started up with no vibration issues or rubs, and the unit has been running smoothly and safely for several years.

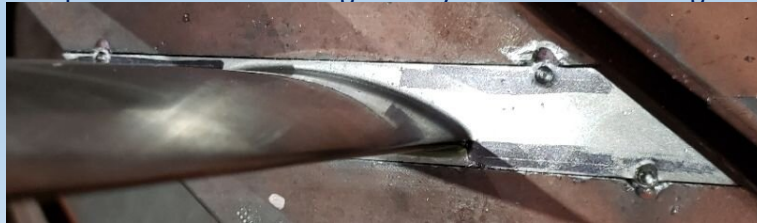
S17 Blade Migration

- A seasonal borescope inspection was performed on a 9FB, finding a 3rd recurrence of S17 blade migration.
- Several of the rotor stakes were undersized, cracked, or pushed flat, allowing blade to migrate axially downstream.
- Both axial staking and flowpath wheel staking were performed previously and failed.

- Stakes were upgraded to flowpath staking -Rev2, where stakes are placed on the vane platform OD.
- Great difficulty was encountered by the OEM in finding consistent staking tooling, procedures to make a consistent stake, and personnel that could perform stakes that would not fail. Multiple tools were used, many personnel applied, and several new blades were scrapped once a stake cracked.
- Each stake had to be inspected, measured, and confirmed to be of adequate quality – 100% stake inspection was required to maintain quality.
- Result: Unit was placed back in operation and is running reliably with no further migration issue reported.

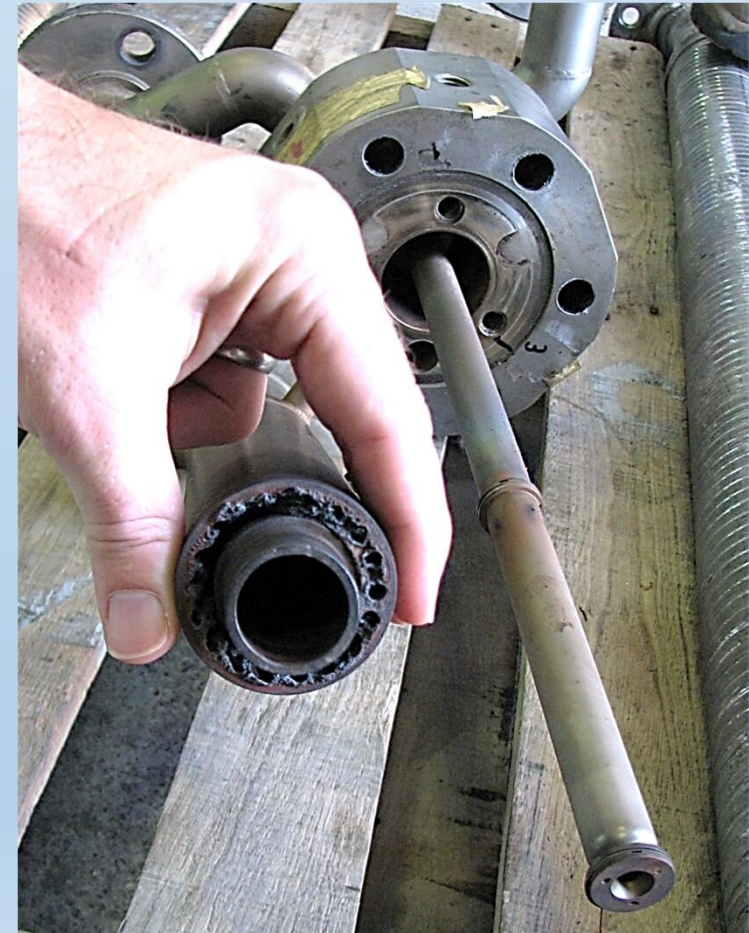
9E Fuel Nozzles Burning Up

- A Turbine owner in Argentina reported burning-up a second set of 9E DLN1 combustion hardware after a repeated combustion inspection.
- A consulting engineer was brought in to troubleshoot, and identified several problems, including:
 - Melting of fuel nozzles on the INSIDE of the fuel nozzle passages,
 - Problems with the installation, design, and condition of the DLN purge valves.

- During subsequent outage, consulting engineer was brought on site to troubleshoot and solve the burning fuel hardware issue.
- Root cause was identified:
 - The DLN-1 purge valves were incorrectly bleeding off combustion gases during operation, pulling the flame back inside the fuel nozzle,
 - The purge valves were determined to be installed backwards, causing the valve disk to be pushed off the valve seat during operation.
- After correction, the unit is now running well.

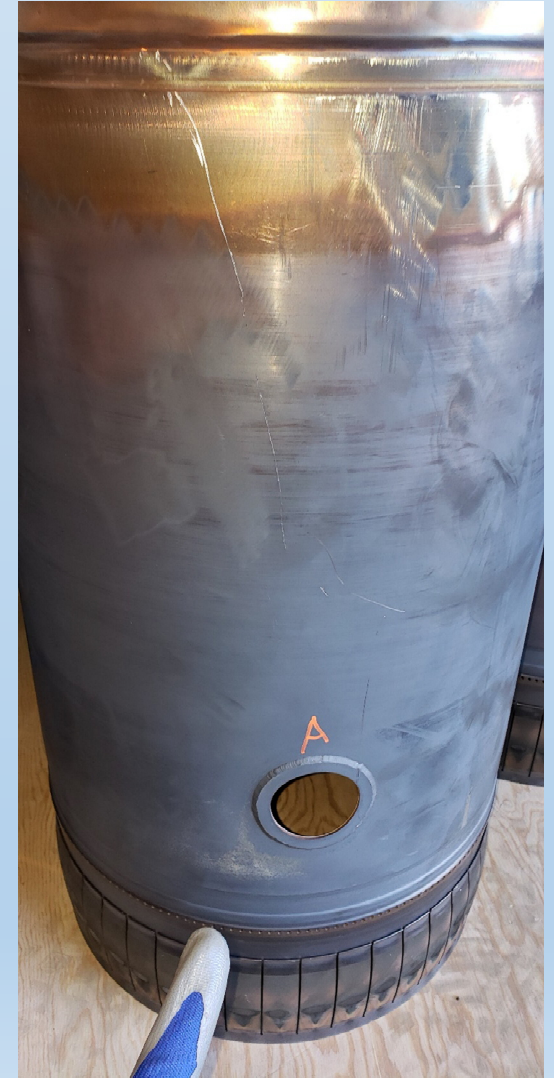
7EA NOx Emissions elevated after an outage

- After a HGP outage, a 7EA was unable to reach base load with acceptable emissions. The unit had to be detuned 15% to stay under NOx limits.

- The Dilution holes in the newly installed sets of liners had a significant change from the removed liner set to the installed set.
 - Removed Set: 2.100" Dilution holes
 - Installed Set: 2.300" dilution holes

- ALWAYS VERIFY DILUTION HOLE SIZES
- Install liners with the same dilution hole size.
- Flow Test Liners when they are refurbished

- Due to schedule considerations, the removed set was refurbishment was expedited, and reinstalled into the unit.
- After correction, the NOx emissions excursion issue was fully resolved, and unit reached base load without issue.

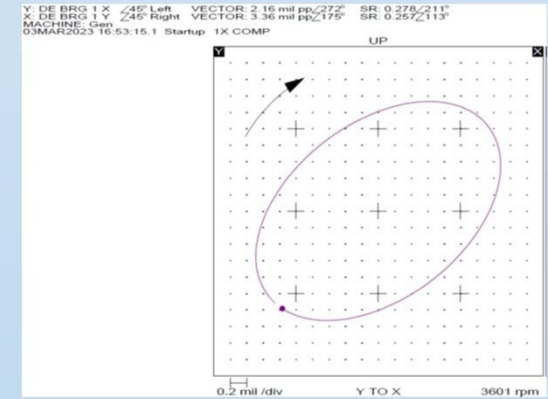
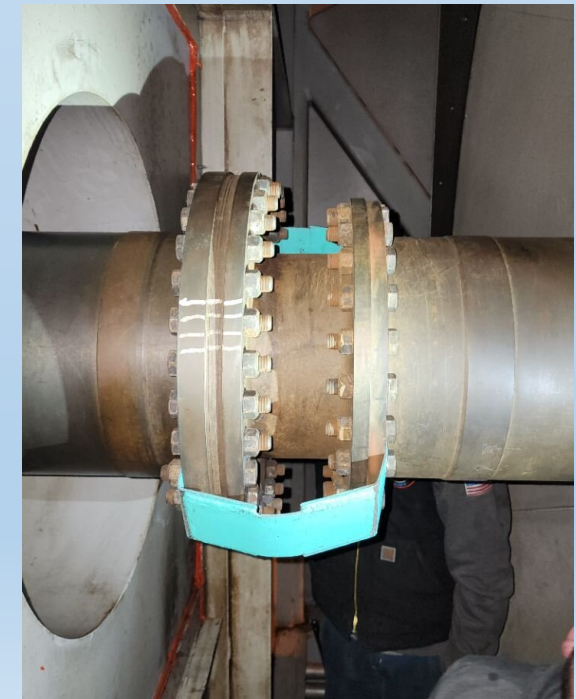
Vibrating Generator after major inspection

- After an LM6000 / Brush BDAX7 major inspection with rotor high speed balancing, generator vibration levels increased from 1 mil to 3.5 mils. A specialist was called in for a balance shot on the generator.
- ADRE Vibration Data was taken, data indicated a clear mass imbalance problem.
- Prior to installing the requested generator balance shot, the consultant requested all covers to be removed for visual inspection of the coupling area.

- Upon visual inspection, the temporary coupling braces were found still attached to the rotor. 3 bolts were left out of one side, and 1 bolt out of the other.
- The temporary coupling braces were removed, all bolting installed, and the unit restarted for a new set of vibration data.
- After correction, the unit is now running at 1 mil on all bearings.
